Shaft Failures

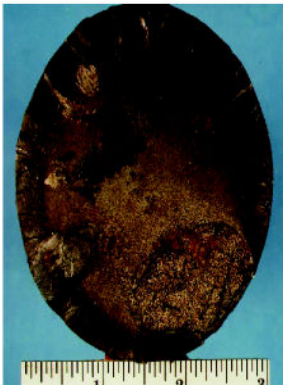
Left: Failure of an Output Shaft on an Emergency Backup Generator at a Powerplant due to Improper Hardness.

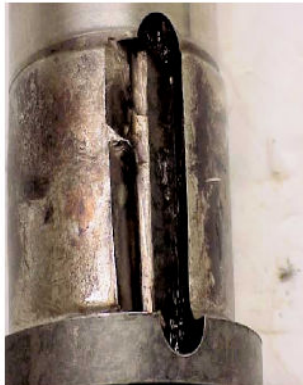
Middle: Keyway Fatigue Failure in a Large 1500 hp Gear Reduction Transmission at a Rubber Processing Plant

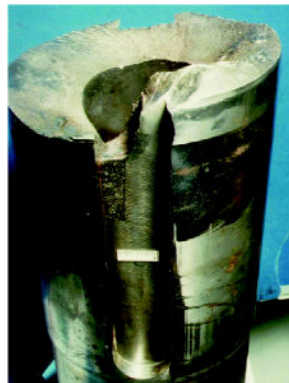
Right: Corrosion Fatigue Failure of a Shaft on a Dryer Roll Paper Mill.
