Microbiologically Influenced Corrosion in Fire Protection Systems

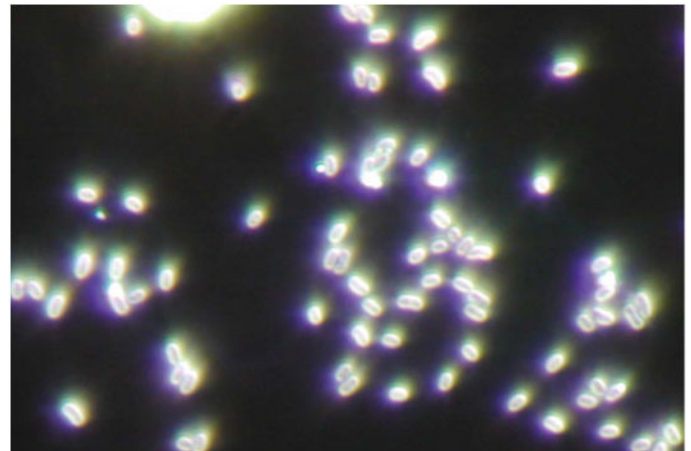
Cells (ovals) of *Thiobacillus ferrooxidans* metabolizing iron by oxidizing ferrous sulfate to ferric hydroxide $Fe(OH)_3$ (white crystals).

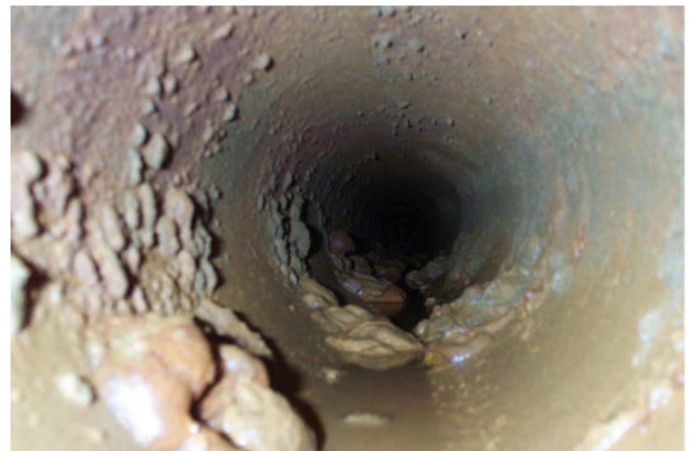
Tuberculation in sprinkler pipe caused by microbial activity.

The most serious consequence of MIC in FPS is mechanical blockage of piping and sprinkler heads. MIC associated organisms can attach to the metallic surfaces of FPS forming corrosion deposits called tubercles that can completely occlude pipes or could potentially shear off and block sprinkler heads. Localized pitting can occur between tubercles and pipe surface (underdeposit pitting) resulting in pinhole leaks.
